INFLUENCE OF TECHNOLOGICAL STRESSES ON THE CORROSION OF WELDED PIPES

Ščekaturovienė, D.; Višniakov, N.

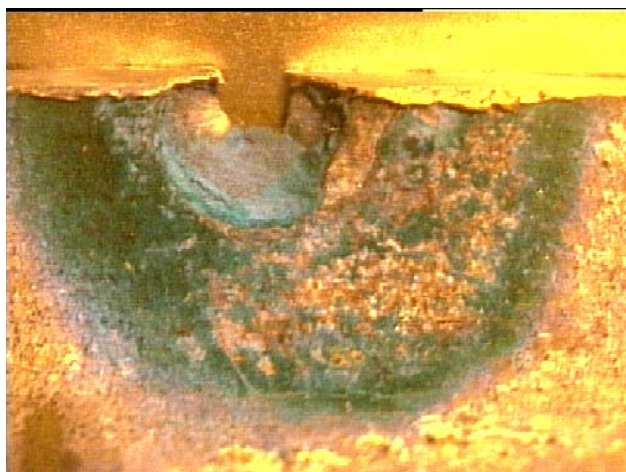
Fig. 2. Corrosion pit on the internal surface of the pipe after exploitation (longitudinal cut): a) corrosion pit geometry, x 5; b) spherical area without oxide film next to the corrosion affected surface, x 30

towards the external painted surface of the pipe. Corrosion products do not cover the whole surface of the corrosion pit. On the spherical part of the corrosion pit surface near the painted surface there are no corrosion products. It is the result of the hydrogen gas pressure (Fig. 2a and 2b). It cannot be the result of oxygen as there is no oxide film. This assumption is confirmed by the fact that there are gas pores on the painted layer of the external surface of the pipe (Fig. 3).
